# TECHNICAL BULLETIN

No: LA-501-012

## Passenger Compartment Water Ingress

Land Rover LR3 (LA)

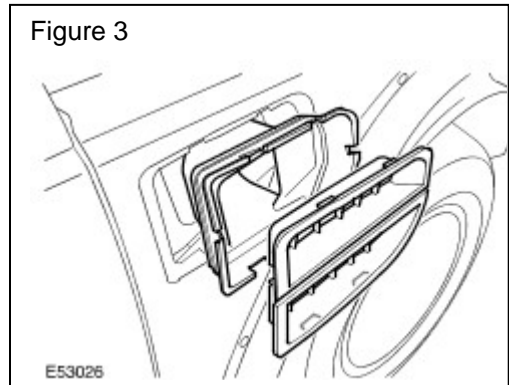
Figure 3

**NOTE:** If both the routing of the roof opening panel drain tube is correct and the valve of the roof opening panel drain tube cannot be faulted, the foam insulation pad may be the cause. The foam sound-deadening pad may have been installed in such a way as to block the roof opening panel drain tube.

1. Remove the fender air intake grill by first pulling up to release the two lower clips, then pulling down and outward to release the two upper clips. (Figure 3)
2. Remove the air duct and foam insulation pad to gain access to the roof opening panel drain tube. (Figure 3)
3. Verify that the drain tube is protruding through the hole in the body. (Figure 4)

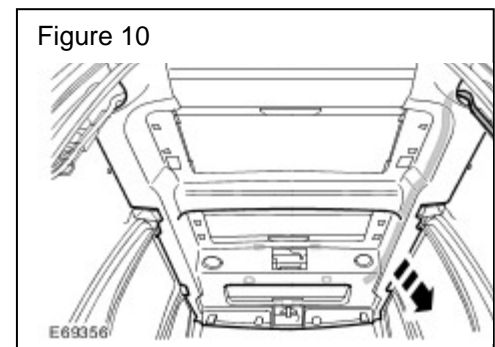
- Collapsed elbow joints
  - Pinched tube
  - Inclined routing

9. If the concern has still NOT been corrected refer to GTR Section 76.64.15 and remove the headliner to gain access to the drain tube. (Figure 10)
10. Inspect for misrouting or kinking of the roof opening panel drain tube, paying particular attention to:

11. Repair drain tube routing as necessary and retest.
12. If satisfactory test is completed, install the headliner.
13. Install the C-pillar lower trim panel.
14. Install the fender splash shield pulled away to access roof opening panel drain tube.

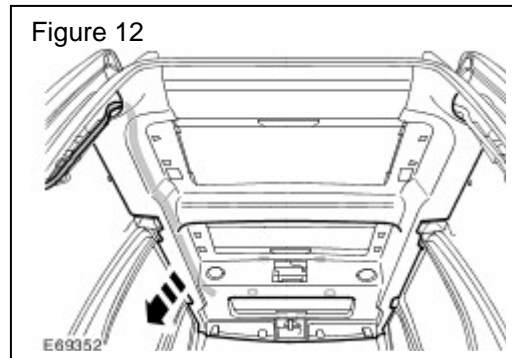
Figure 12

- Collapsed elbow joints
  - Pinched tube
  - Inclined routing
11. Repair drain tube routing as necessary and retest.
12. If satisfactory test completed, install the headliner.

9. If the concern has still NOT been corrected refer to GTR Section 76.64.15 and remove the headliner to gain access to the drain tube. (Figure 12)
10. Inspect for misrouting or kinking of the roof opening panel drain tube, paying particular attention to:

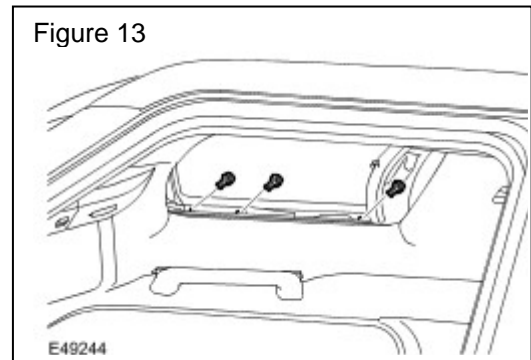
1. Open the roof opening panel blind, leaving the roof opening panel closed.
2. Verify that the glass is centered in its opening.
3. Verify that the front edge is set flush or up to 1.0 mm (0.040 in) below the roof line.

4. Verify that the rear edge is set flush or up to 1.0 mm (0.040 in) higher than the roof line.
5. From inside the vehicle, verify that all six (6) Torx screws securing the roof opening panel are correctly positioned and tightened to **6 Nm (4.5 lbf-ft)**. (Figure 13)

6. If the roof opening panel is not set within the specified conditions or if any Torx screw is loose, align the roof opening panel as follows:
  - Loosen the six (6) roof opening panel Torx screws

- Align the roof opening panel so it is centered in all directions to the exterior roof panel opening
  - Verify that the exterior front and rear edges are set within the specified conditions

- Tighten the six (6) roof opening panel Torx screws to **6 Nm (4.5 lbf-ft)**.
7. Verify proper operation of the roof opening panel.
8. Close the roof opening panel blind.
