TECHNICAL BULLETIN

No: LTB00085
Issue: 1
Date: 19 Sep 2007

Windshield Wiper Blades Knocking/Juddering – Diagnostic Procedure

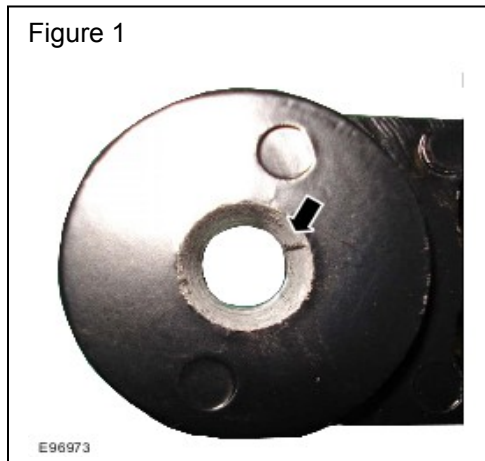
2. Visually inspect the windshield wiper arms and spindles.
 - Figure 1 is an example of a wiper arm which has been under-tightened. The arm has loosened and the splines of the spindle have worn away the material of the arm.
 - Figure 2 is an example of a spindle with a build-up of material from the wiper arm. This material should be cleared using a wire brush.
 - Figure 3 is an example of a wiper arm which has been misaligned on installation. The arm has worn in one area. The resultant wiper performance is affected by the incorrect angle of 'attack' of the blade on the glass, causing a poor wipe, noise and/or judder.
3. If any of the above conditions are found, the other wiper arm head should also be inspected for the same symptoms.
4. Any wiper arms showing evidence of the above conditions should be replaced.

5. Install the wiper arms.
6. Tighten the nut to the correct torque for the vehicle:
 - Freelander (LN) **18 Nm (13.2 lbf ft)**.
 - LR2 (LF) **25 Nm (18.4 lbf ft)**.
 - LR3 (LA) **18 Nm (13.2 lbf ft)**.
 - Range Rover (LM) **34 Nm (25 lbf ft)**.
 - Range Rover Sport (LS) **18 Nm (13.2 lbf ft)**.
