TECHNICAL BULLETIN

No: LTB00217
Issue: 1
Date: 20 MAY 2010

Passenger Compartment Water Ingress

VIN: 5A000360 - 9A513325
Model Year: 2005 - 2009

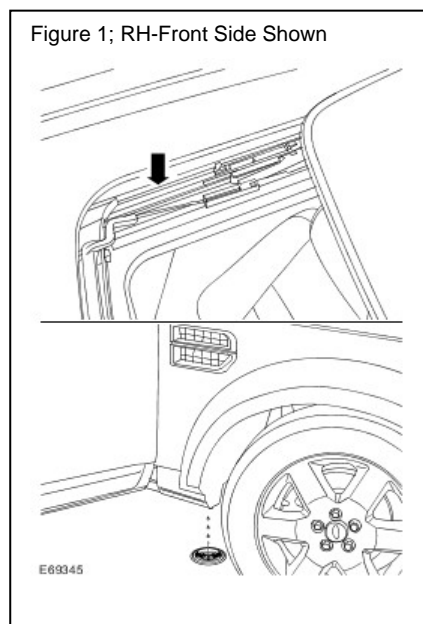
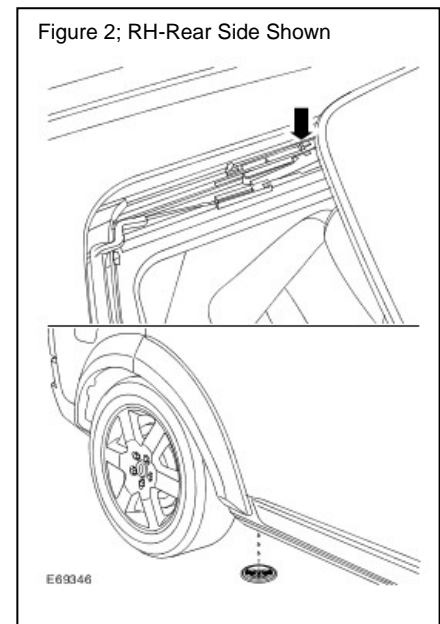
- Place the vehicle on dry level ground.
- Fully open the sunroof panel to gain access to the water trap.
- Carefully pour water into the water traps, one corner at a time so that the water drains into the drain hole and drain hose.
(Figure 1 [front] and Figure 2 [rear])
- Confirm that water has pooled on the ground at all four drain points under the A-pillar and C-pillars on both sides of the vehicle. (Figures 1 and 2)

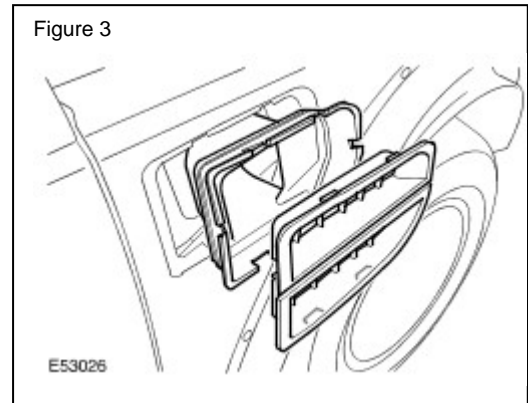
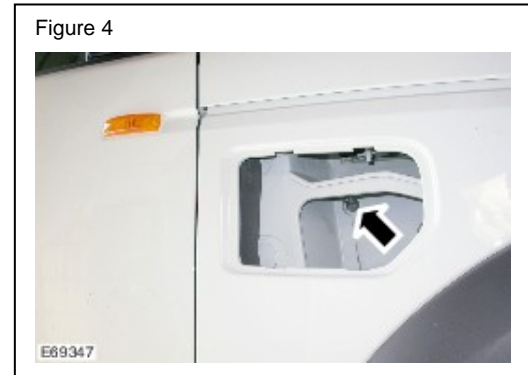
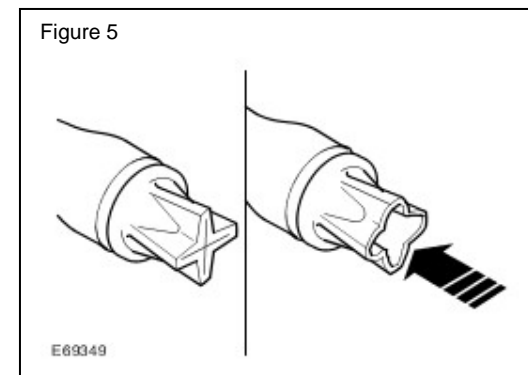
NOTE: If both the routing of the roof opening panel drain tubes are correct and the valve of the roof opening panel drain tube cannot be faulted, the foam insulation pad may be the cause. The foam sound-deadening pad may have been installed in such a way as to block the roof opening panel drain tube.

1. Remove the fender air intake grill by first pulling up to release the two lower clips and then pulling down and outward to release the two upper clips. (Figure 3)
2. Remove the duct and foam insulation pad to gain access to the roof opening panel drain tube.
3. Verify that the drain tube is protruding through the hole in the body. (Figure 4)
4. If the tube is not protruding through the hole in the body perform the following steps to correctly route the roof opening panel drain tube:
 - Connect and secure the drain tube through the hole in the body
 - Verify the valve of the roof opening panel drain tube can be fully opened. (Figure 4)
 - If the valve does not open, cut as required to permit full opening. (Figure 5)

5. Remove and then reinstall the foam sound-deadening pad, taking care to ensure that the roof opening panel drain tube valve locates in the indent in the foam insulation pad to avoid crimping the tube.
6. Confirm free-flow of water by repeating the **TEST SUNROOF DRAINS** procedure for the right front drain.
7. If satisfactory test is completed install the duct and fender air intake grill.
8. If satisfactory test is NOT completed, blow out the drain tube with compressed air and test again.

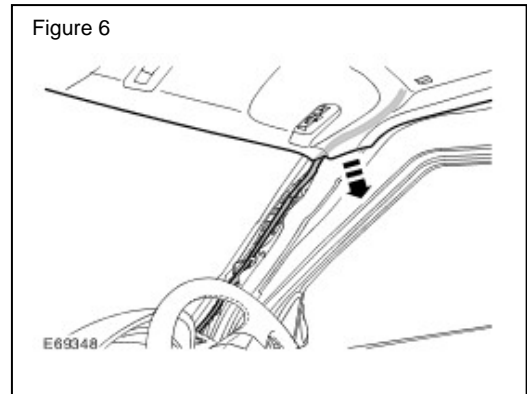
10. Inspect for misrouting or kinking of the roof opening panel drain tube and inspect for: (Figure 6)
 - Collapsed elbow joints.
 - Pinched tube.
 - Inclined routing.

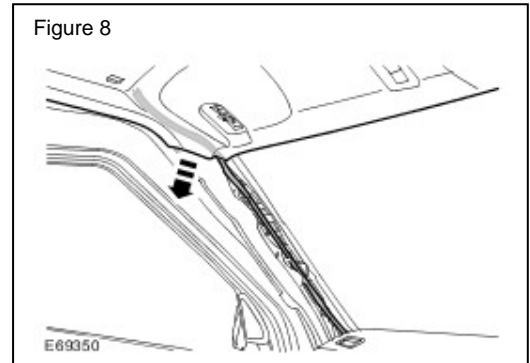
8. If the concern has still not been corrected unresolved, refer to Workshop Manual (GTR) Section 501-05, *Interior Trim and Ornamentation*, and remove the headliner to gain access.
9. Inspect for misrouting or kinking of the roof opening panel drain tube, paying particular attention to: (Figure 8)
 - Collapsed elbow joints.
 - Pinched tube.
 - Inclined routing.
10. Install the CJB.
11. When testing is satisfactorily completed, refer to Workshop Manual (GTR) Section 501-08, *Exterior Trim and Ornamentation*, and install the LH front wheel arch lining and LH front wheel arch molding.

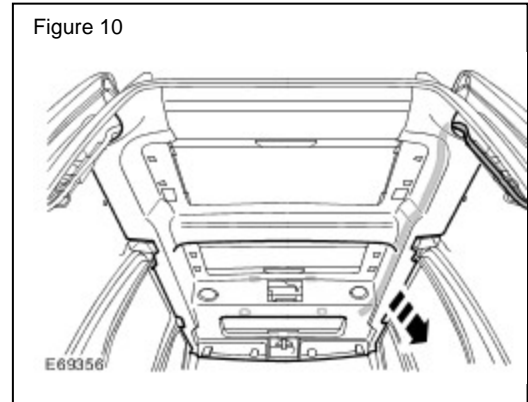
9. If the concern has still not been corrected refer to Workshop Manual (GTR) Section 501-05, *Interior Trim and Ornamentation*, and remove the headliner to gain access. (Figure 10)
10. Inspect for misrouting or kinking of the roof opening panel drain tube, paying particular attention to:
 - Collapsed elbow joints.
 - Pinched tube.
 - Inclined routing.
11. If removed, install the headliner.
12. Install the C-pillar lower trim panel.
13. Install the fender splash shield removed to access roof opening panel drain tube.
