## How to remove the dashboard to access the heater stepper motors

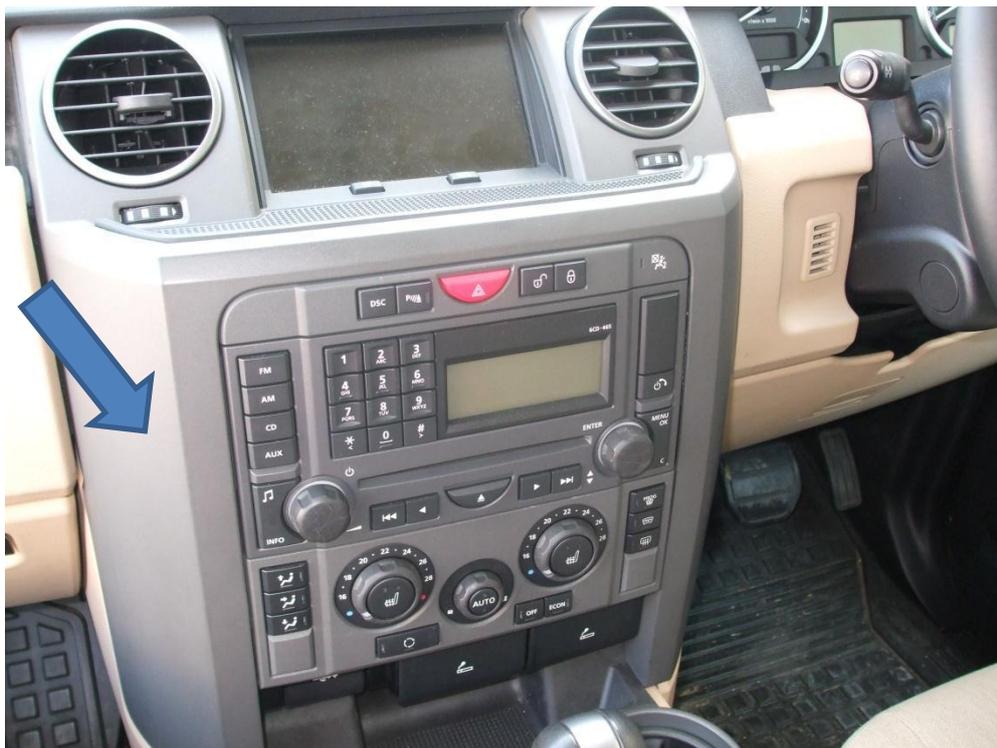
3. Start by removing the 'H' trim around the controls. There's four clips, two at the bottom and the other two about half way up; pull at the sides near the bottom towards you. The metal clips are specially designed to spring off into the dark recesses of the dashboard never to be seen again and annoy you by rattling around; be happy that it's your fault and not the LR dealer that you're paying hundreds of pounds for the privilege. My trim has been off so many times I've removed all the clips and the trim is now only a push fit.

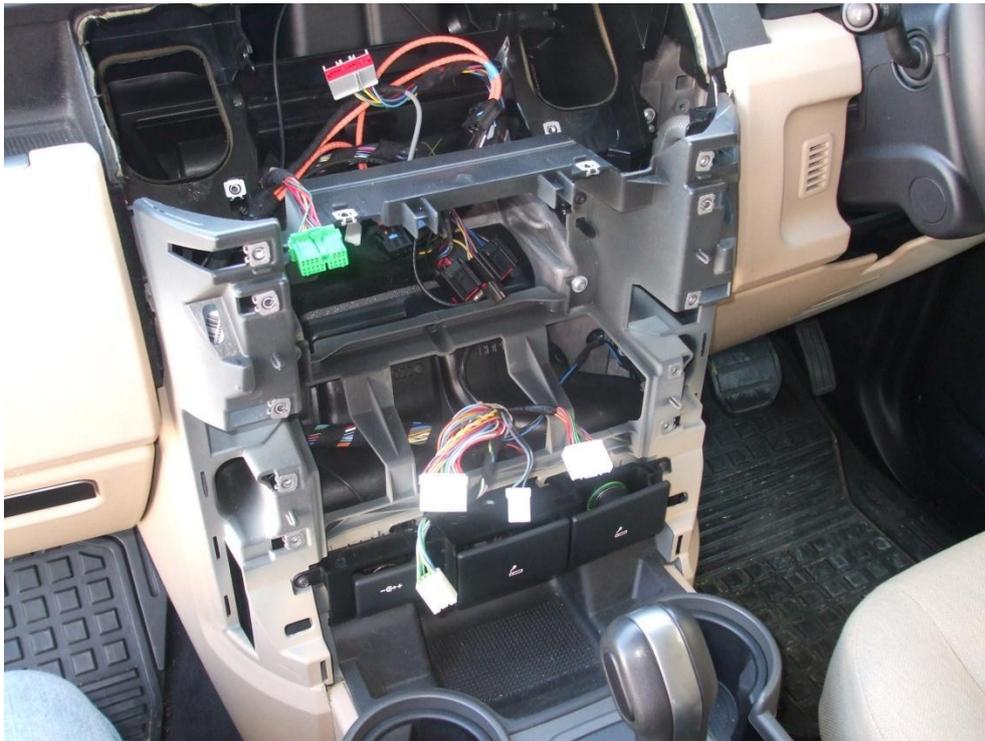
5. Remove the sat nav, stereo, heater controls etc. Be careful of some of the connections at the rear, especially the optic fibre ones. Note that the bottom one, the ashtray and 12v sockets, won't come out yet.

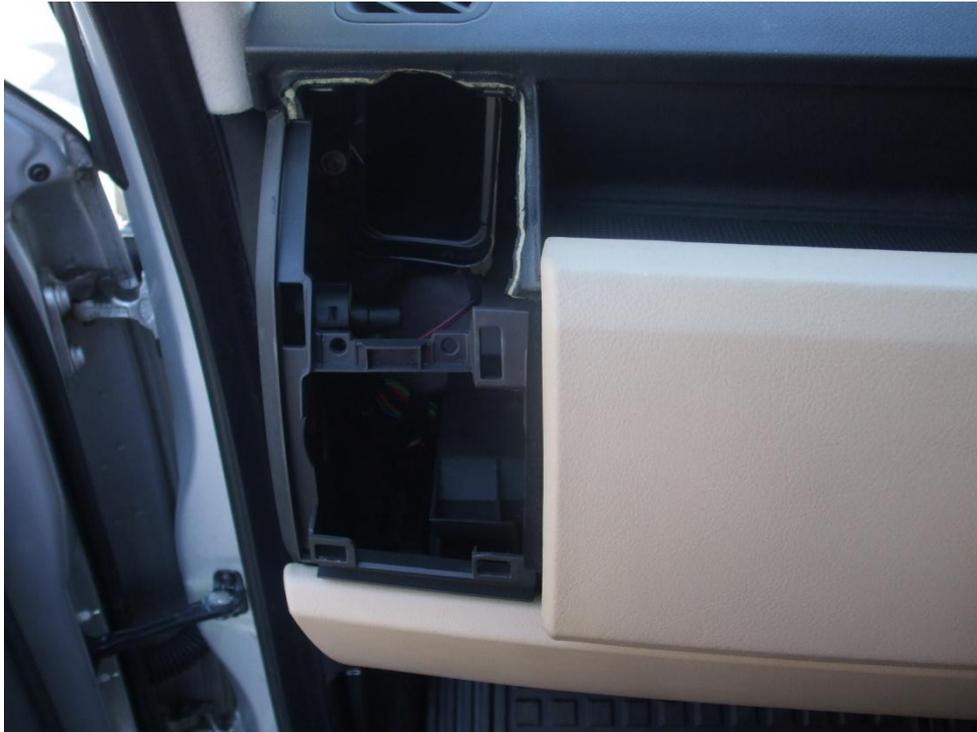
6. Remove the passenger side vent. Just pull, from around the bottom. This step is the beginning of the removal of the upper glovebox. I had to do this to successfully remove the main centre section of the dashboard by bending its sides outwards (if this doesn't make sense at the moment, don't worry, it will do in time); I had to do this because I was unable to get the centre console between the seats far back enough so it could be removed the way I think it should be. The console couldn't go back far enough because I was unable to work out how part of the wiring loom disconnected from the automatic gearshift (if it does at all) so it would only move backwards a certain amount. Others may have more success.

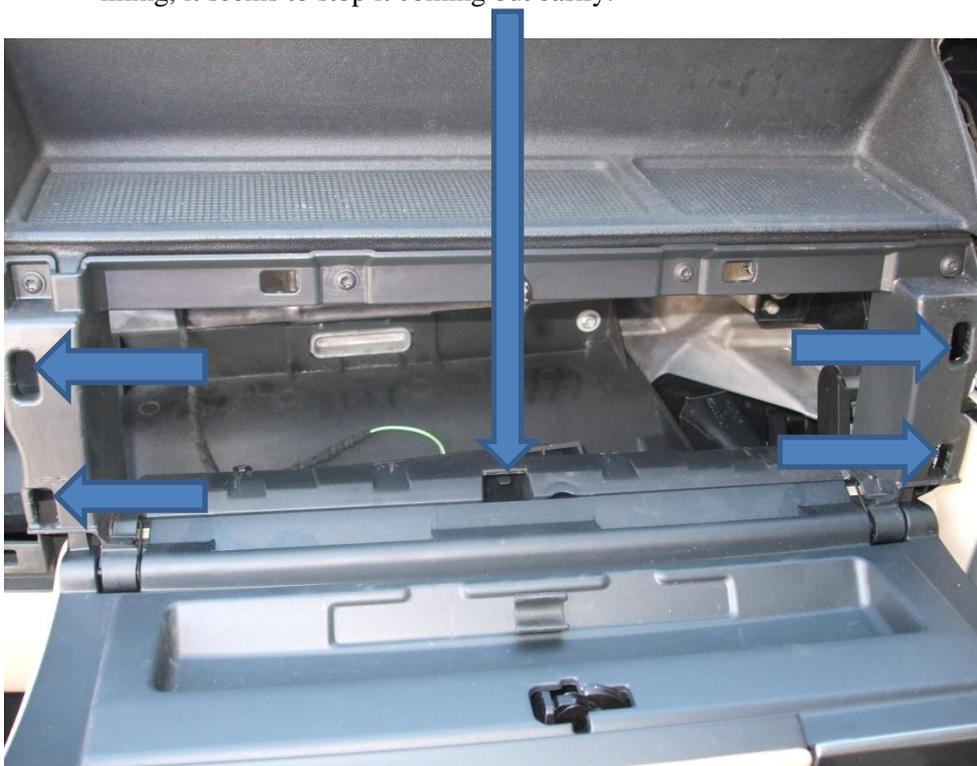
7. Remove the inner bit of the upper glovebox. There's two spring clips on either side, located where the arrows are. This was a real pain for me and I thought it was going to break; careful use of a screwdriver to prise it off was needed, plus pushing from behind (explains why the vent had to be removed first). The hole in the bottom centre takes a plastic clip from the inner lining, it seems to stop it coming out easily.

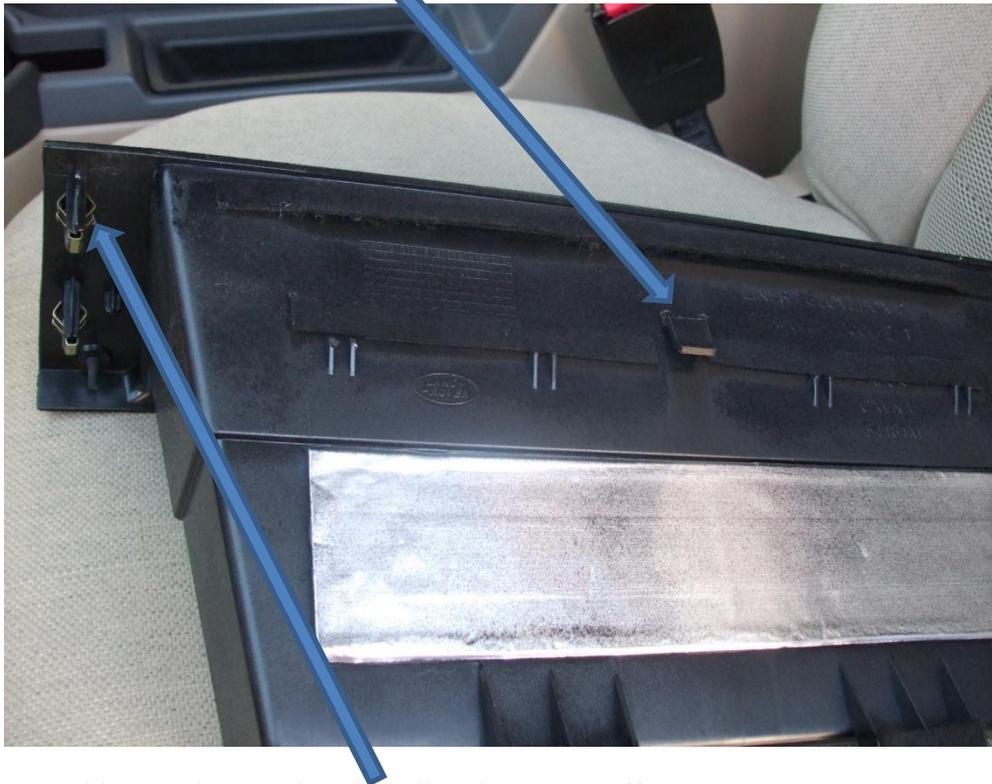
8. ... and here's the clip that makes withdrawing it difficult

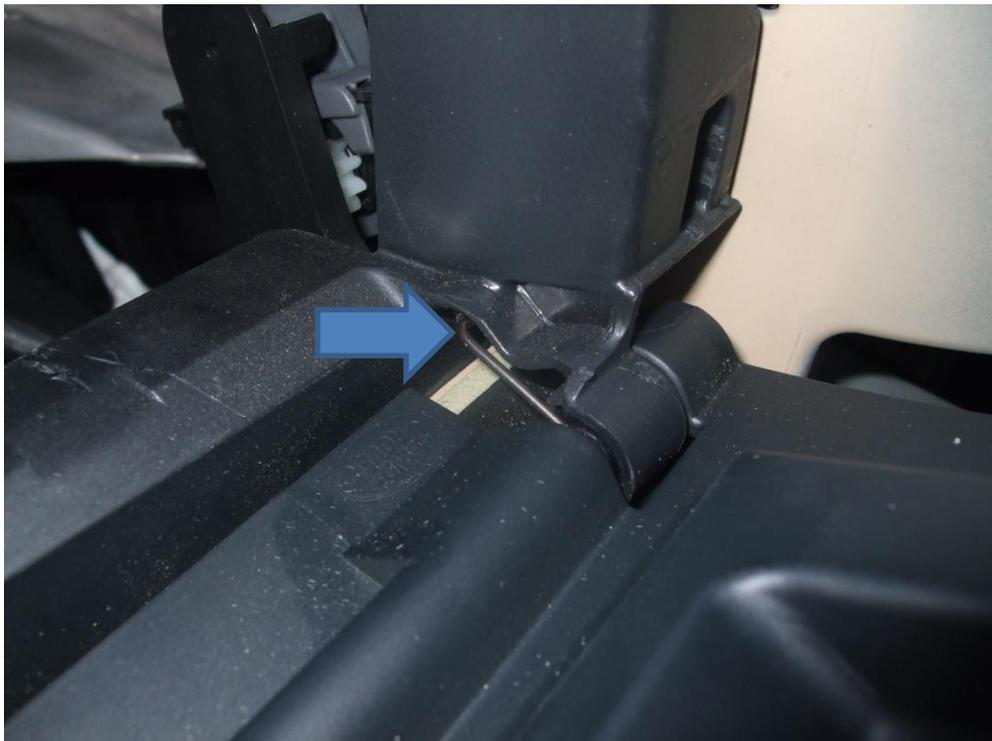
... and here's the metal spring clips that come off...

9. Now pull out the two spring clips, both sides

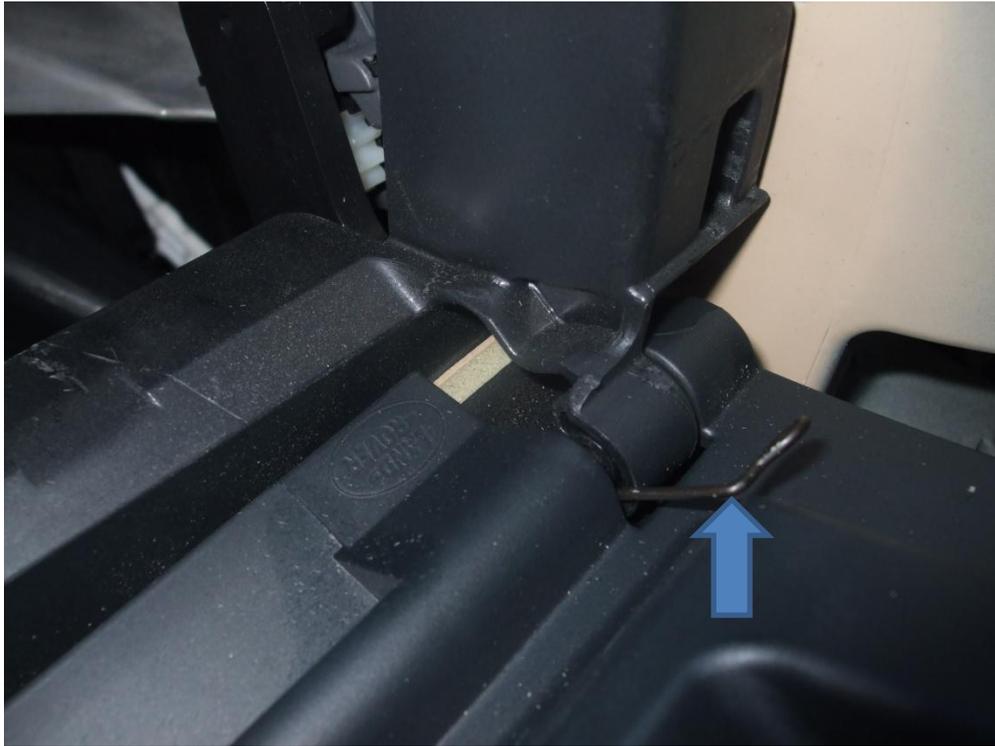
like this

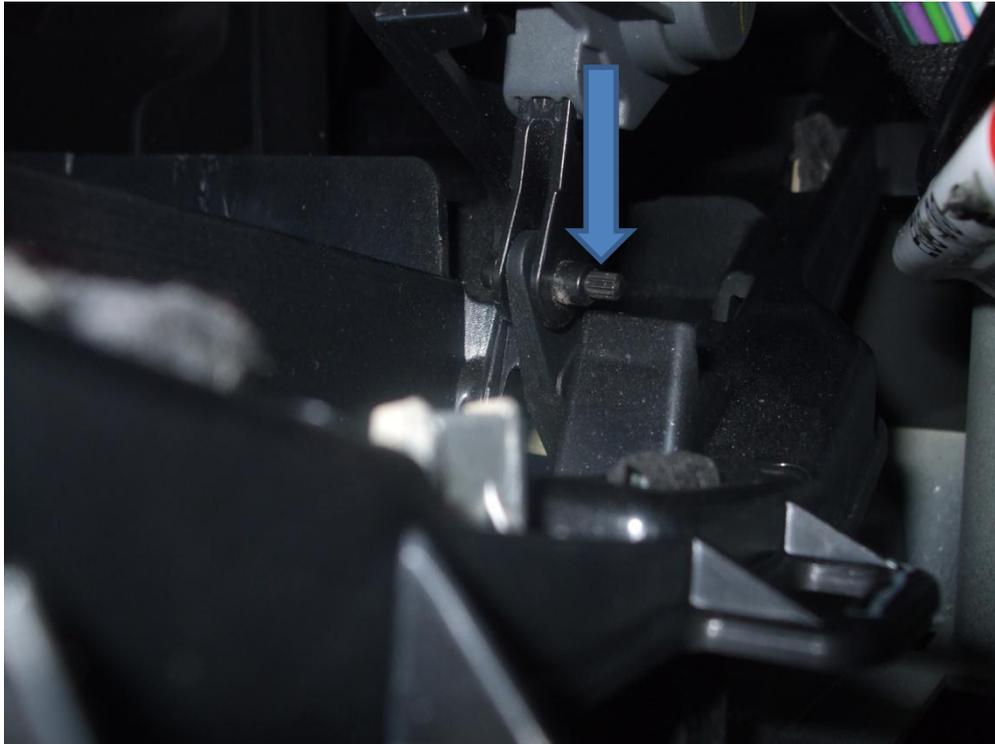
10. Looking inside (where the satnav once was), find the mechanism that dampens the opening of the glovebox door. Move it to a point where you can see as shown below (the pin won't be half out... you need to do this) and push it from the left-hand side with a small screwdriver etc. Don't push out too far or else it's goodbye pin. Pull out the remainder of the way with long-nose pliers.

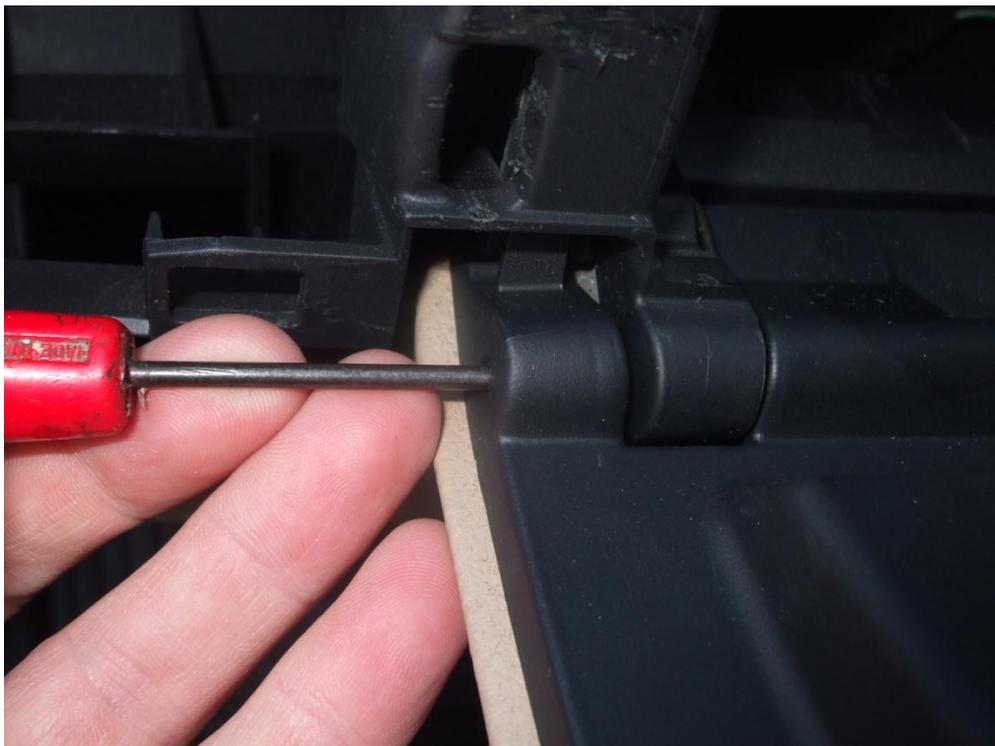
11. Then push inwards the hinge pins on both sides. The right one needs varying lengths of stiff wire.

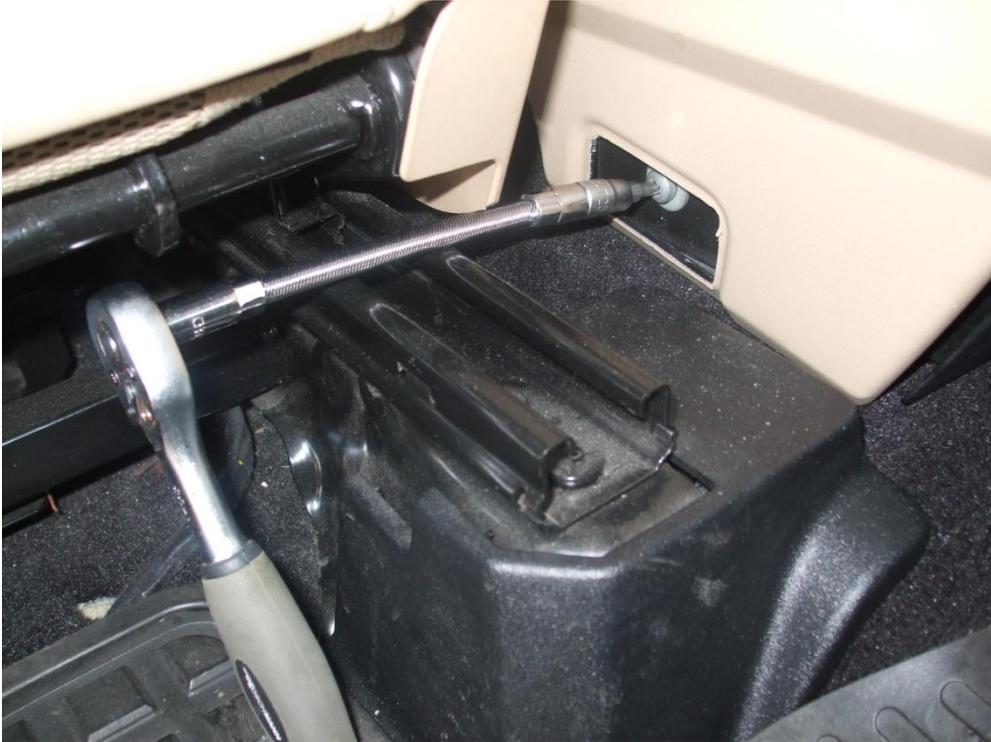
12. Remove the T30 Torx screws from either side of the centre console by sliding the first rows seats forward as far as they will go. A ¼" ratchet should fit; a flexi drive may also be needed as the seat runner just gets in the way.

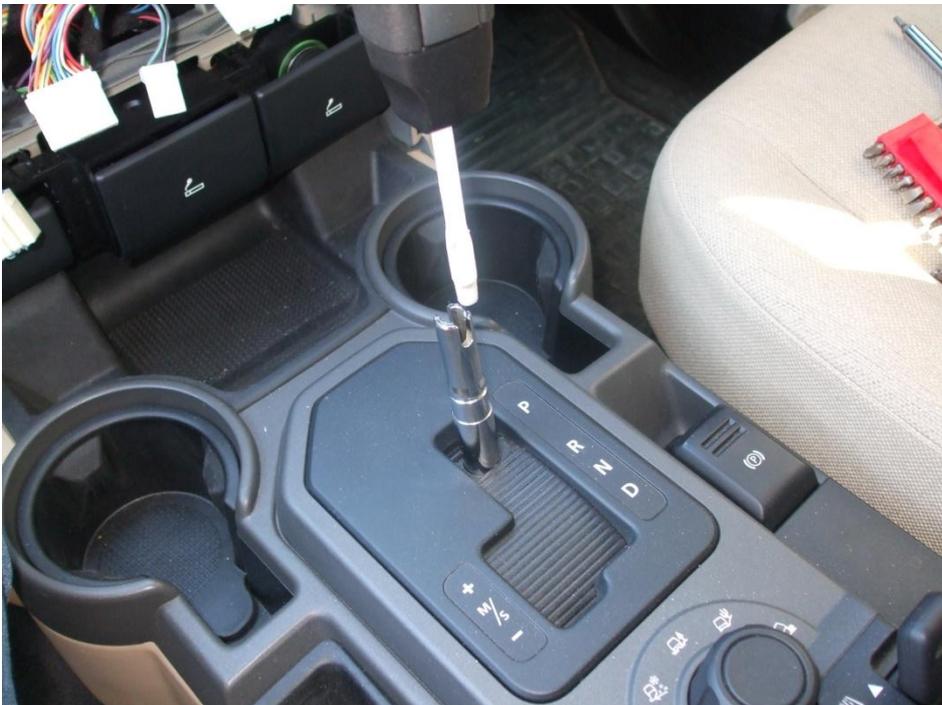
13. If you have an auto like me the next bit is relevant. If you have a manual, sorry, I haven't got a clue. Hold the gear selector handle and pull upwards... hard... but straight in line with the lever so as not to break the plastic bit goes downwards inside.

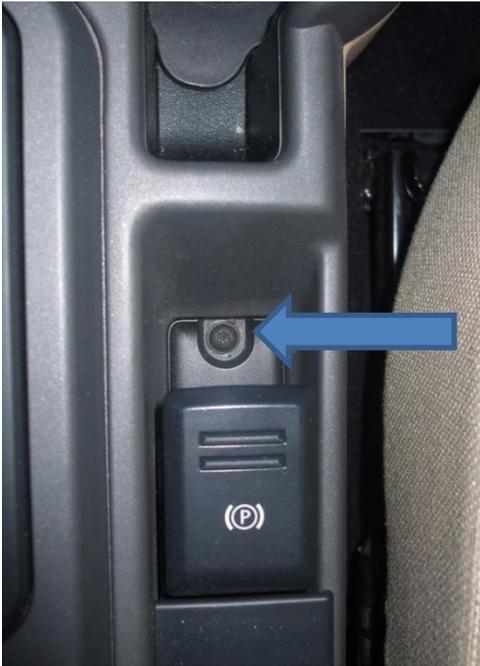
14. Remove the Torx screw from just in front the EPB handle.

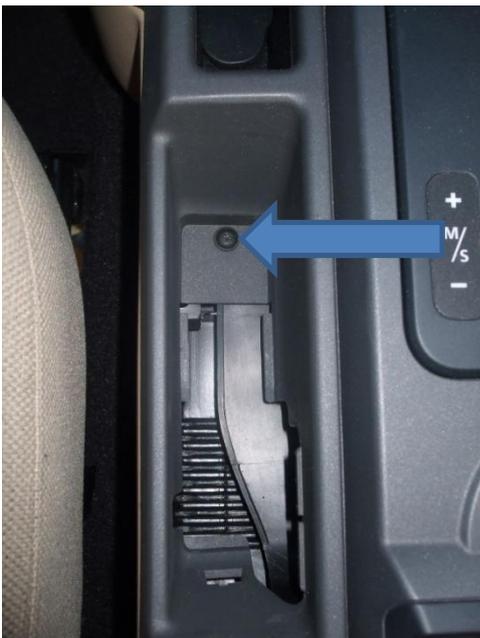
15. Remove the rubber sunglasses holder, then the plastic bit underneath it. A hidden Torx screw should be found underneath. Very cunning Mr Land Rover.

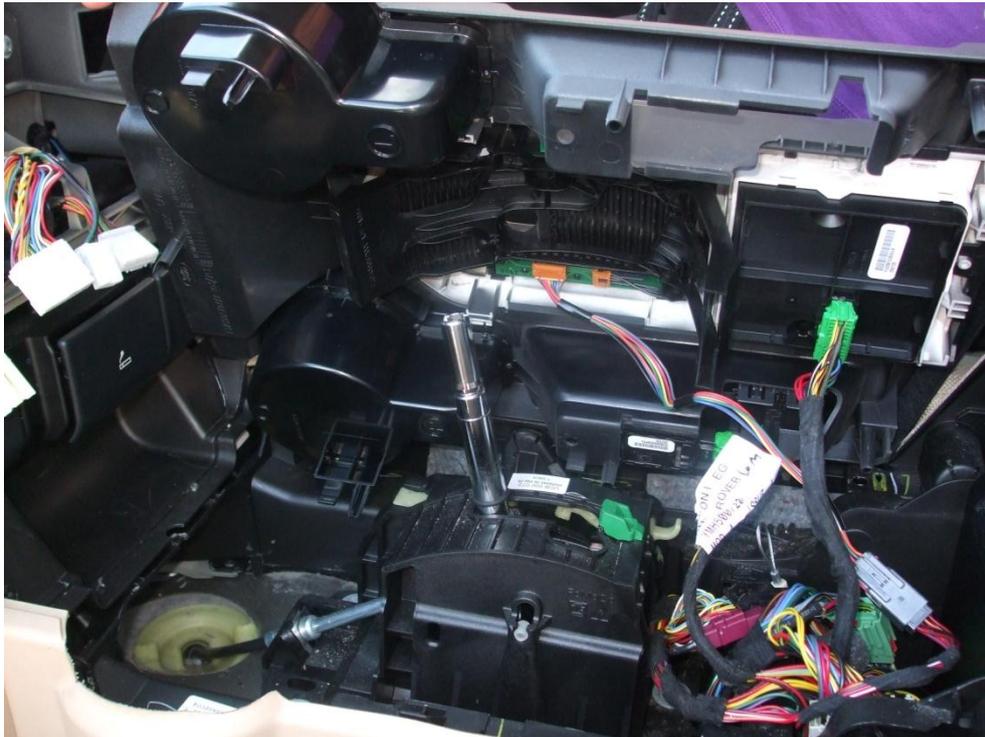
16. Once the top is removed you'll see as below.... obviously this is from the passenger side; I'm right handed and the whole job just seemed easier that way. There's three wiring looms that need to be unplugged so that the top can be removed.

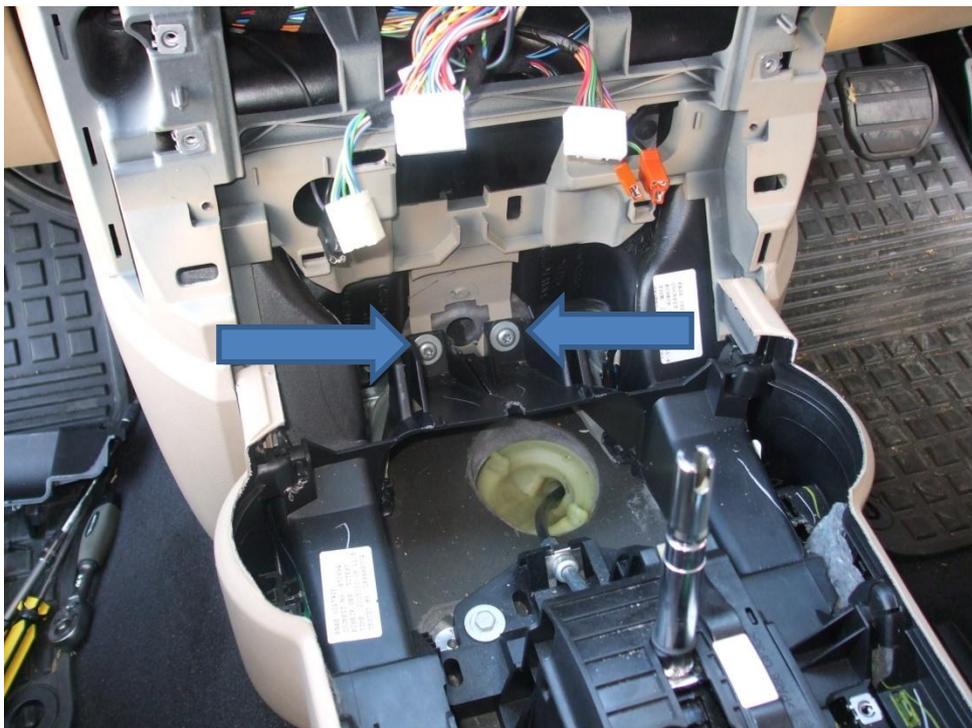
17. Remove these two Torx bolts.

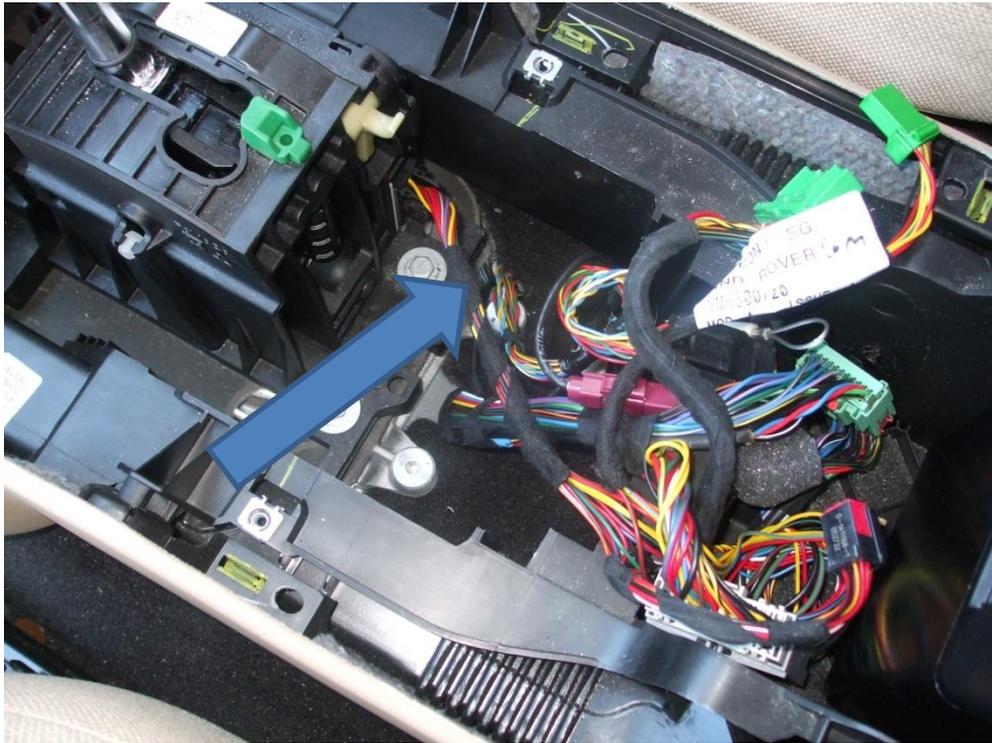
18. Raising the console at the rear slightly, slide it backwards as far as it will go. Because I never found a way of disconnecting the wiring loom indicated it will only go so far.

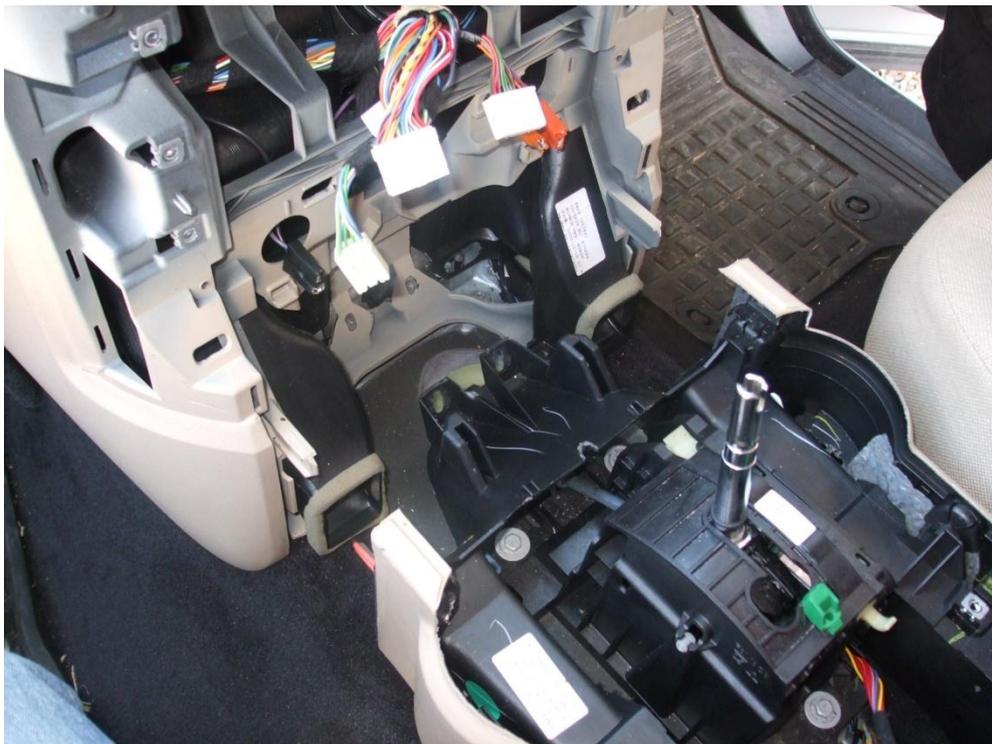
... and the console moved backwards...

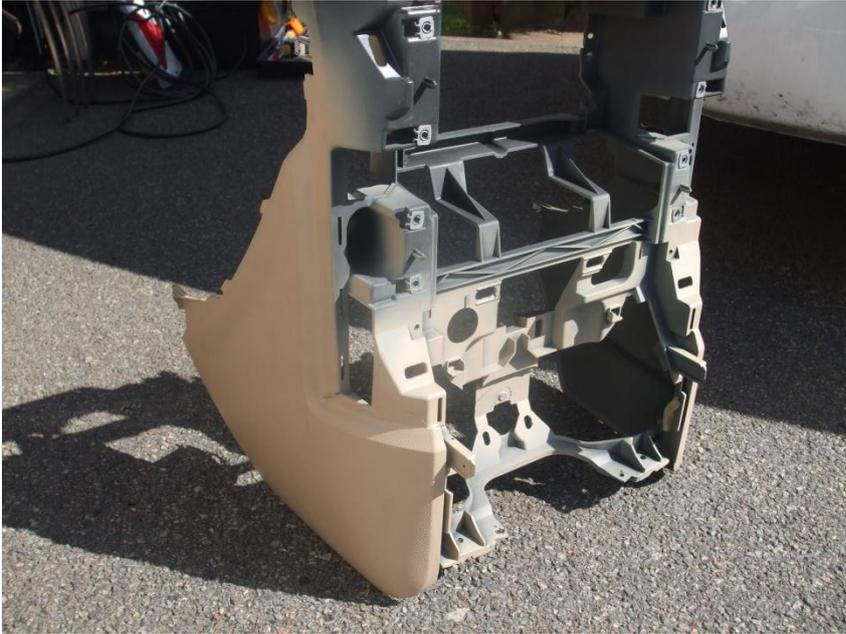
19. Now... this bit needs to come out. This is what it looks like once removed. When I did it the first time, this was the trickiest bit. I have no idea what this is called, so just for the sake of it I'll refer to it as Tim.

23. Remember this picture? Tim now needs to come out. This is the bit we've all been waiting for. It would have been a whole lot easier if the centre console could have slid back further or come out altogether. I should have taken a photo to show the next bit but forgot in all the shouting with the wife sitting alongside in the driver's seat. Sorry. Honestly, it is a two person job to make sure nothing breaks or is scratched.

Pull it all towards you, there's a couple of spring clips on the sides and locating lugs. Then hinge it forwards from the top, bending the sides outwards as far as they will go. Hopefully you can jiggle it all and it will come out. Notice that there's plastic ducting at the bottom which needs to be negotiated, but it does disconnect and come out at the top if needs be.

The arrows on the photo show the sides that have to be bent outwards.

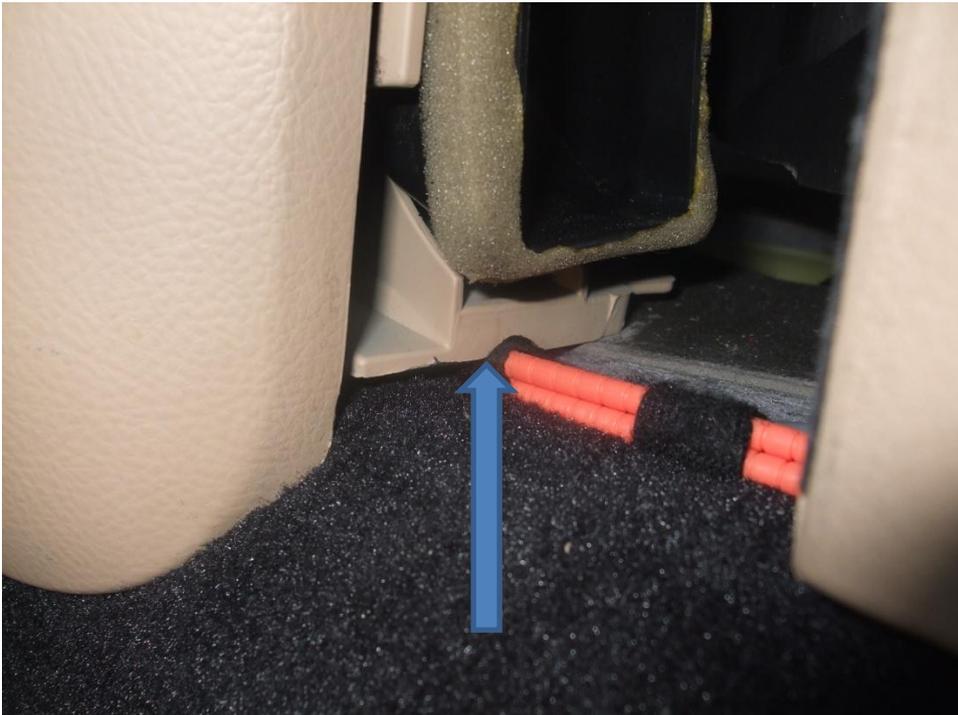
The trouble is the cables as shown below, which I think are fibre optic so damaging them would be the last thing you want to do, are attached to the bottom of Tim by plastic fittings which are push-fitted in, and onto which the cables are taped. The best way I found, as the clips wouldn't pop off, was to wrestle underneath and cut the tape – either with a knife (carefully) or side-cutters.

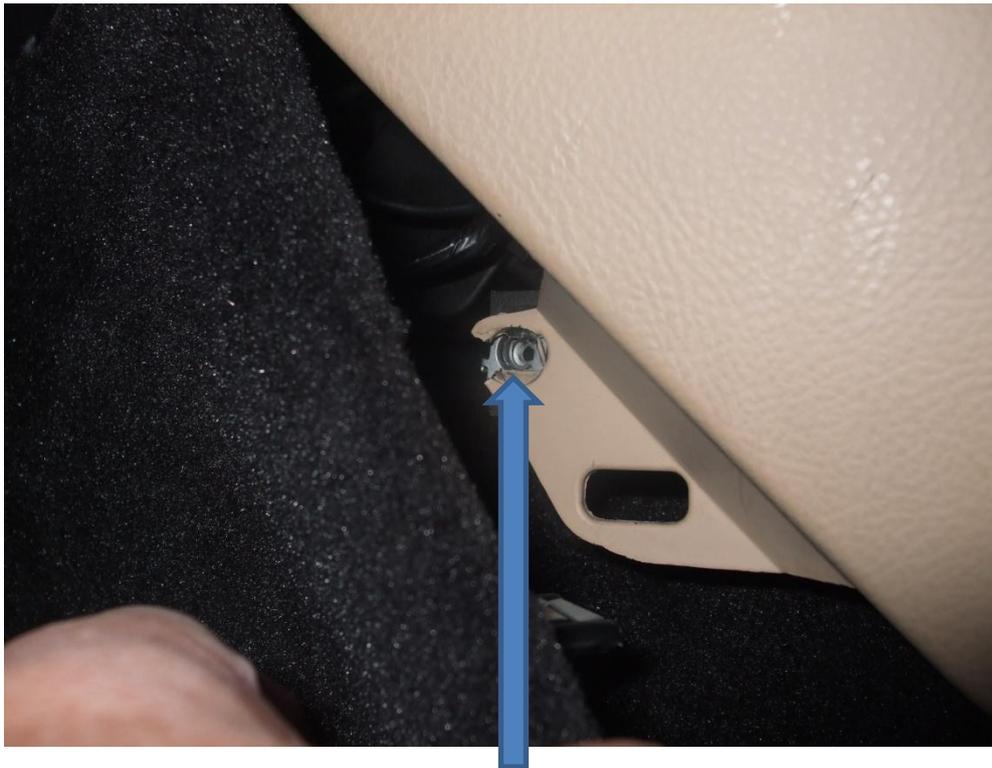
20. On the sides of Tim are two screws. Pop off the carpet trim first.

This is with the screw removed on the passenger side.

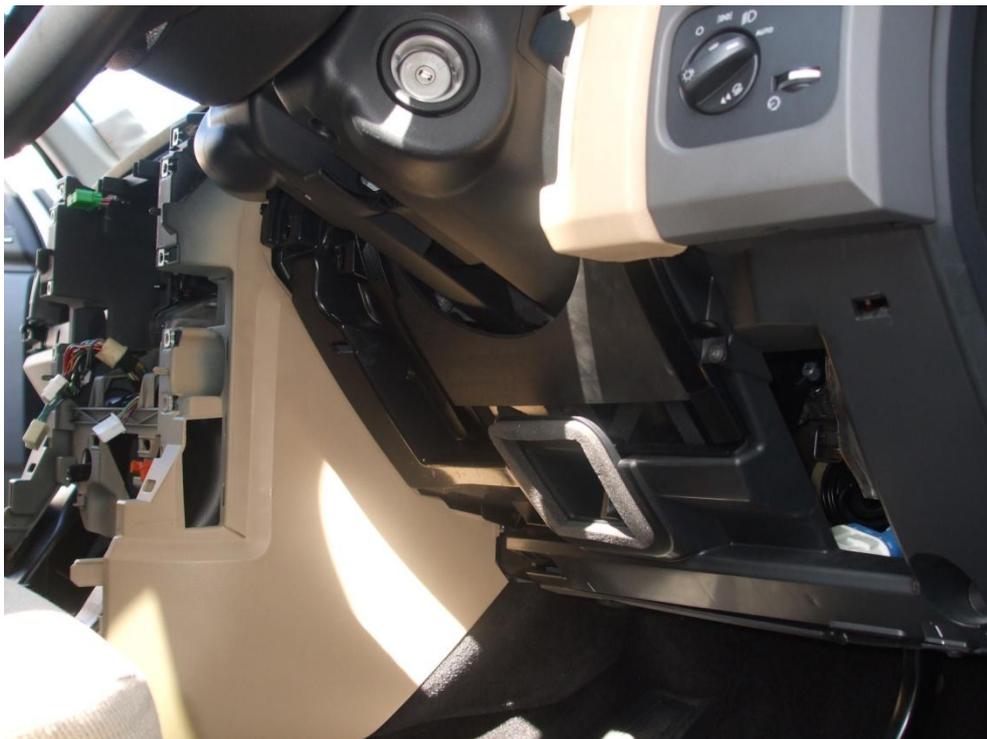
21. Remove the panel below the steering wheel. There's two spring clips at the top, and it's hinged at the bottom.

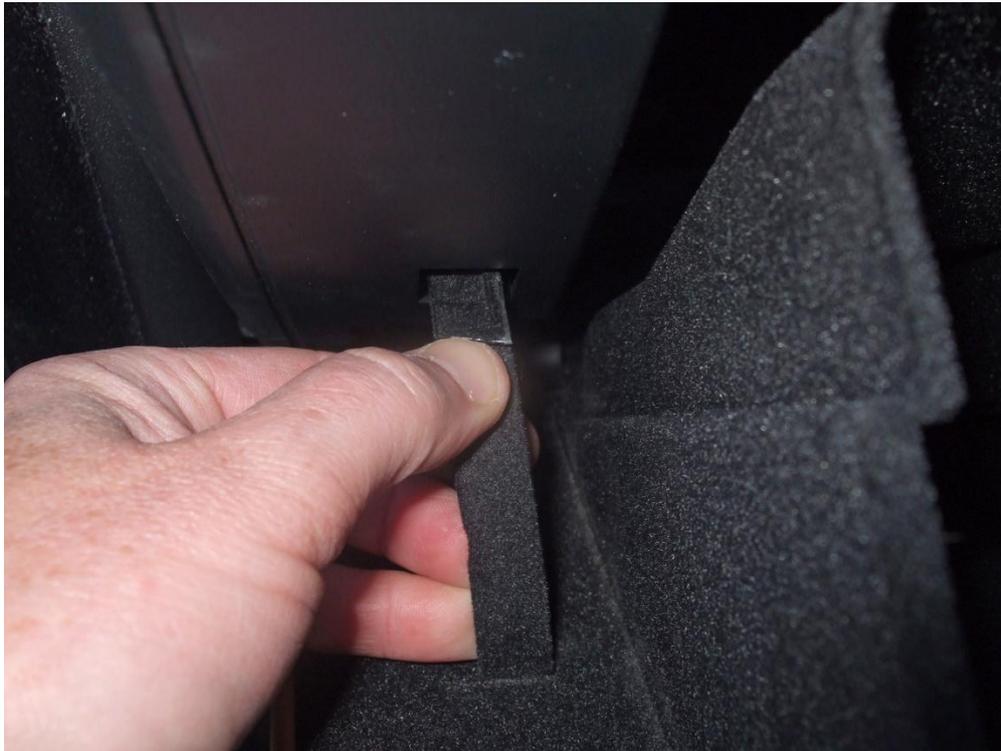
22. Squeeze the stays on either side of the lower glovebox when open, so it drops down to its lowest position.

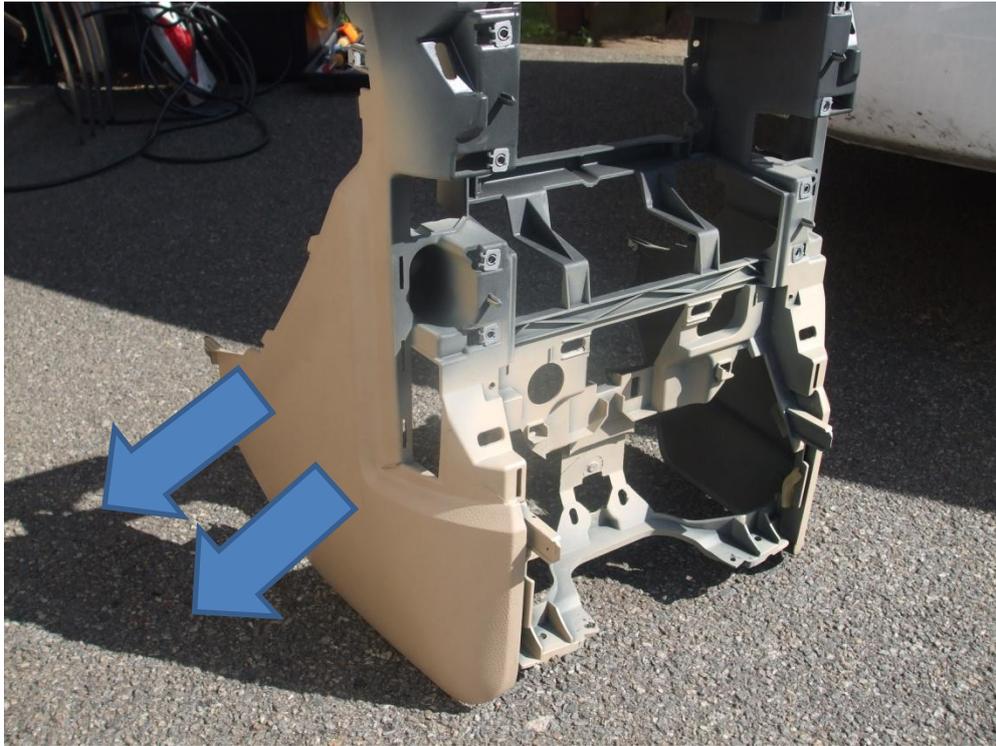
24. Good. So now your pride and joy should look like this. Let's just hope it all goes back together again.

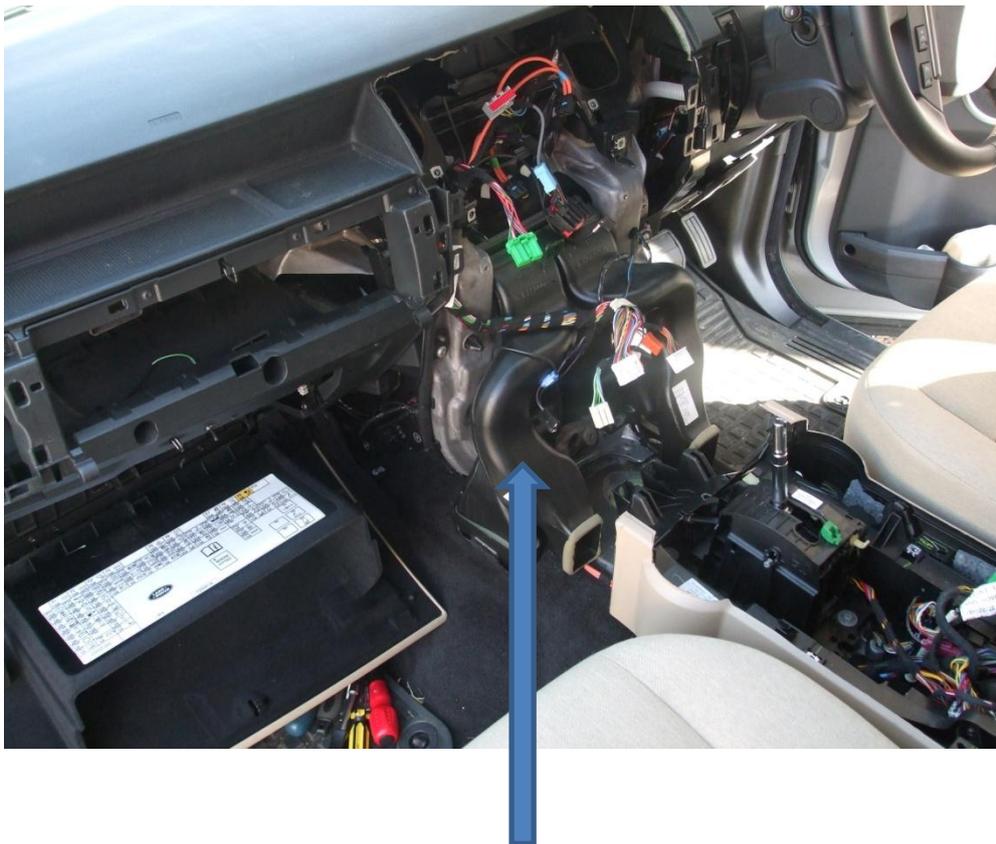
Here's the plastic ducting I referred to in point 23.

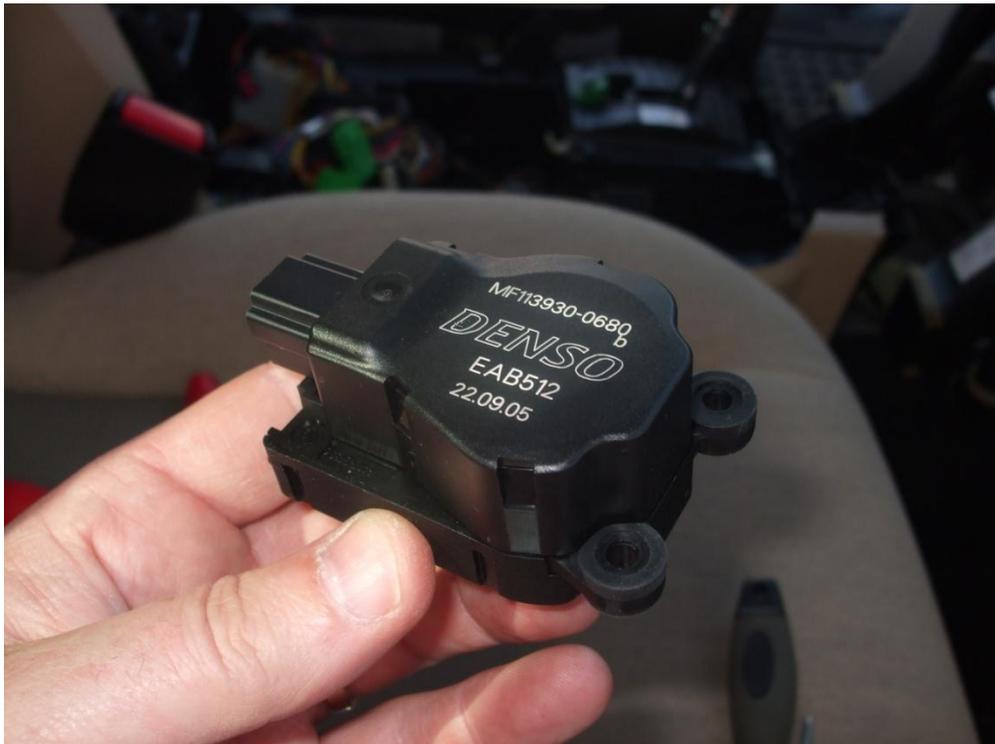
25. Okay. Here's one of the stepper motors we are after.

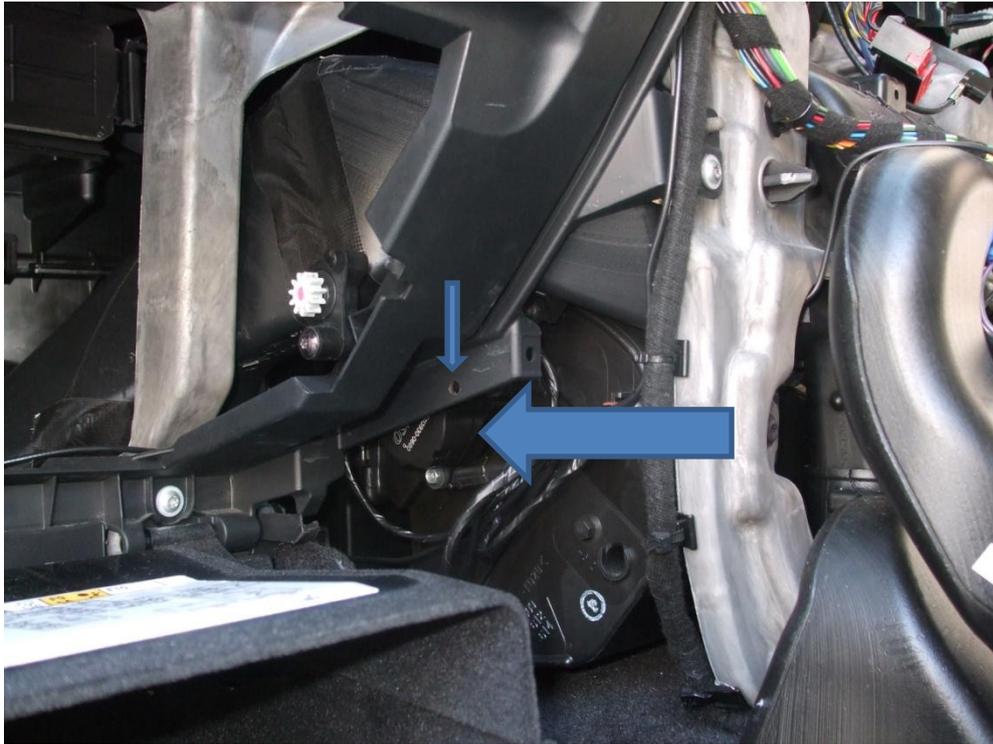
26. From what I found out by trial and error, there's four of these little fellas hiding away. There are two on the left (passenger side) – the bottom one (big arrow) does the passenger side temperature mix, the top one controls the air flow between the footwell and the face vents.

The small arrow indicates a hole I had to drill in the plastic to be able to remove one of the three fixing screws.

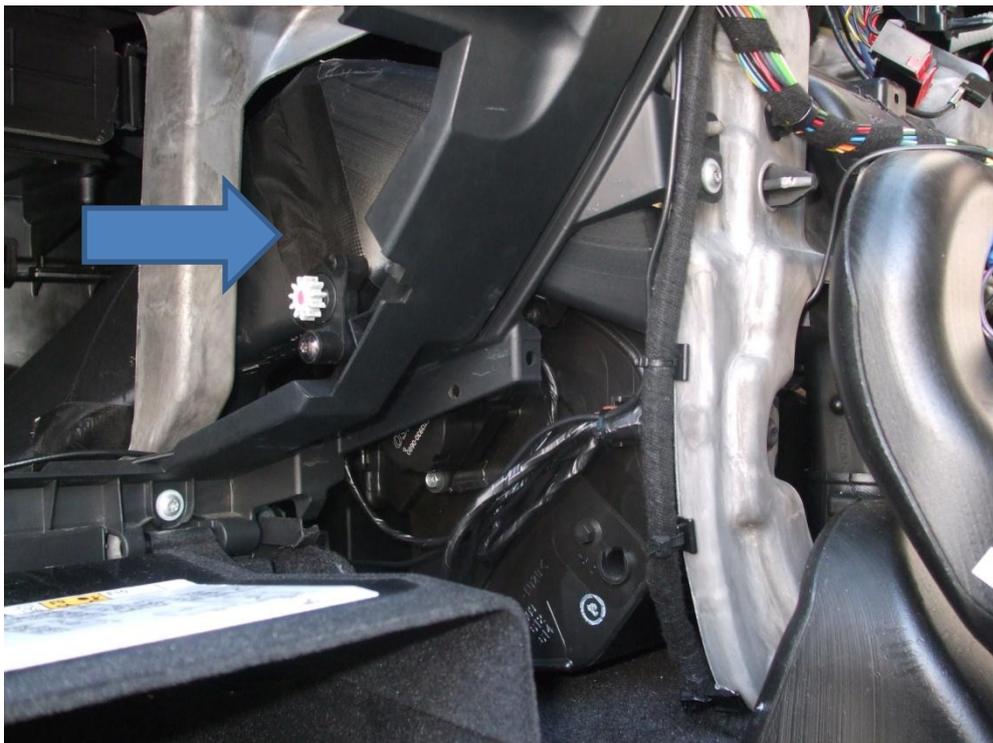
Arrowed in the next photo is roughly where the upper (footwell and face) motor is. Access to this involves removal of the plastic ducting.

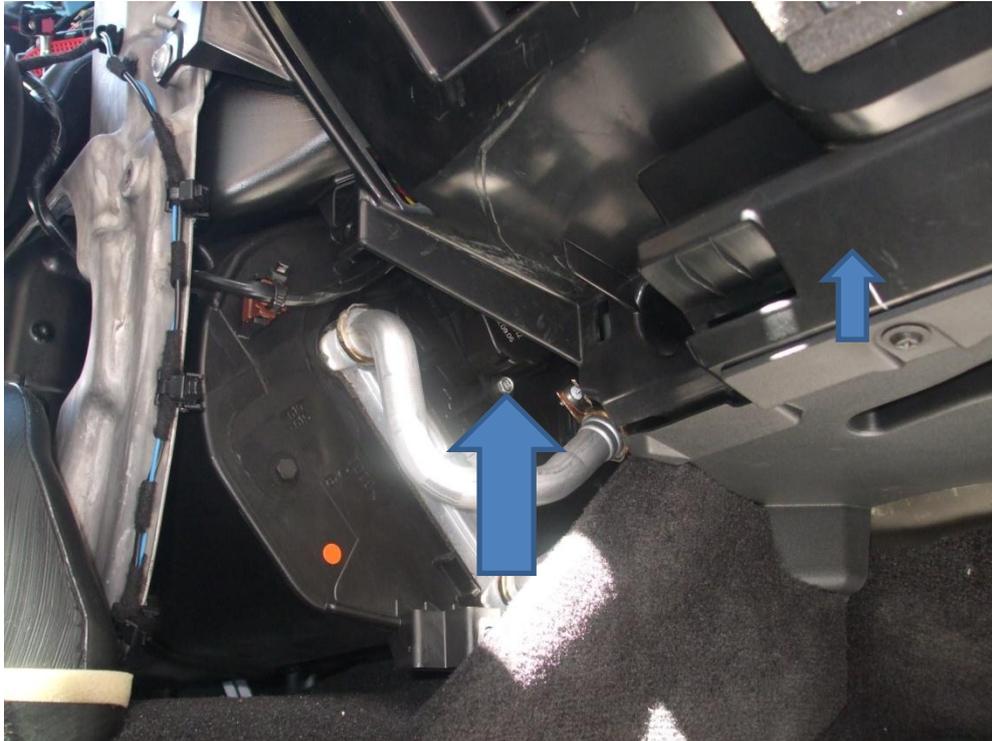
27. Here's the right (driver's) side. Again, the lower one (large arrow) does the driver's side temperature mix. The upper one (completely hidden from view by plastic ducting) does the windscreen and side window (the ones that can't be opened/closed) vents.

Hopefully the motor you're after is on the passenger side, because the driver's side ones are a *nightmare* to get to. Access probably could be vastly improved by removing the plastic surrounding the steering wheel (small arrow, above). However, I believe that total removal involves taking the steering wheel and steering column controls etc off, so now its decision time.

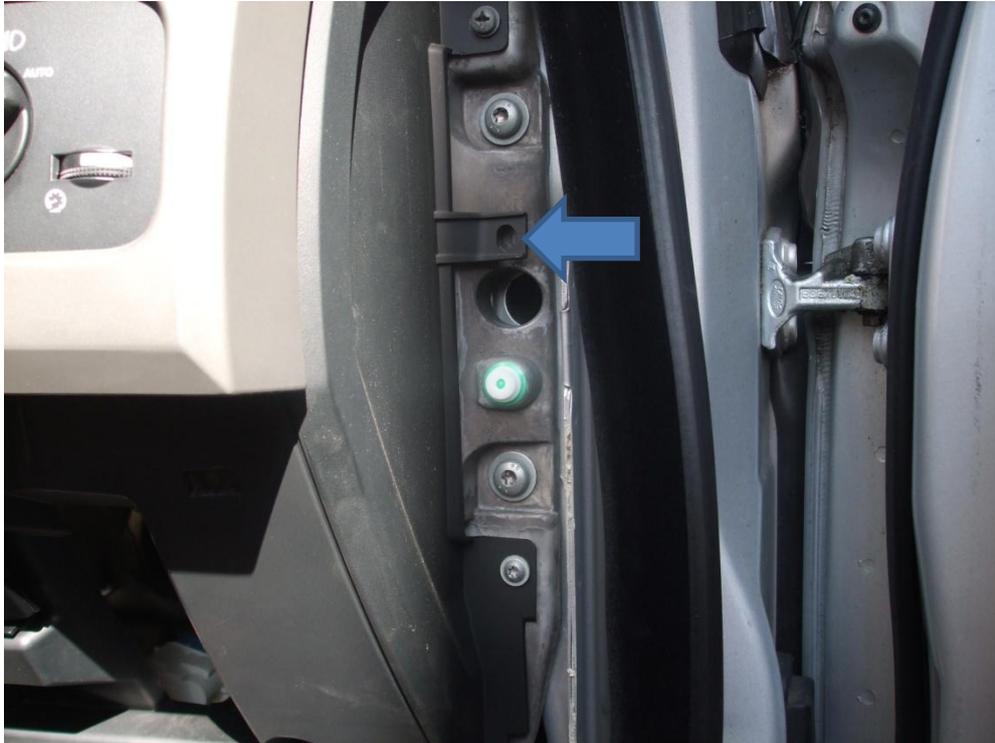
28. I opted not to remove the steering wheel, so needed to take out all screws and bolts (such as below – after removing the black trim) so the plastic can be forced as far forwards at the bottom as possible. The wiring to the OBD socket also stops it, so remove the two screws securing the socket as well.

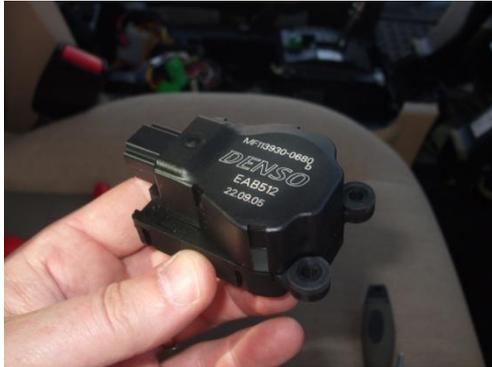
29. So, here's the photo again of what hopefully you've managed to remove. Swap it with a new one and fit everything back together again.

Tip – don't use the 'trial and error' approach I used the first time when I was working out how it all functioned. Removing one known working motor and fitting it in the faulty location to prove a suspected dodgy motor caused problems that sent me around in circles. It appears that the system needs to see all four motors so it knows what it's doing on car switch-on. The bottom ones (temperature mix) seems to cycle a bit to work out where they are before the heater control resets itself.
