Connector: C2922

Part No.: YPG800220

Harness: CABIN HARNESS

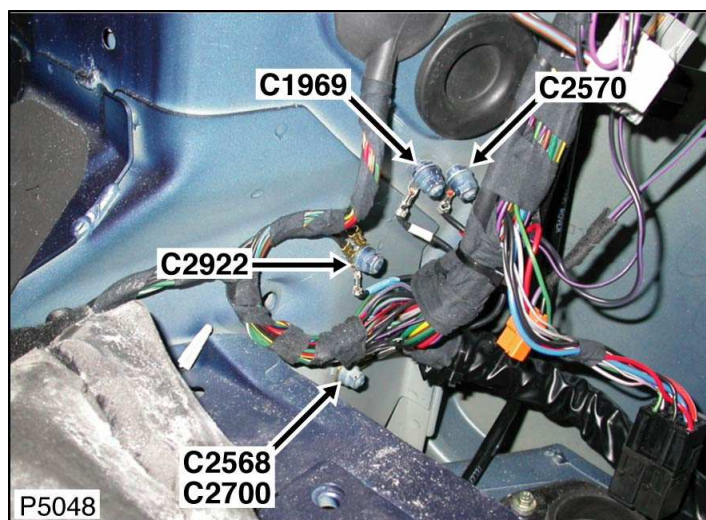
Description: Ground point

Location: Base of 'D' post LH side
